THE BANDINI-COTA ADOBE PRADO DAM RIVERSIDE COUNTY  
CALIFORNIA(U) GREENWOOD AND ASSOCIATES PACIFIC  
PALISADES CA R S GREENWOOD ET AL. NOV 83  
DACW09-83-R-0002

THE BANDINI-COTA ADOBE,  
PRADO DAM, RIVERSIDE COUNTY, CALIFORNIA

TEST EXCAVATION

Prepared for the  
U. S. Army Corps of Engineers, Los Angeles District  
Contract No. DACW09-83-R-0002

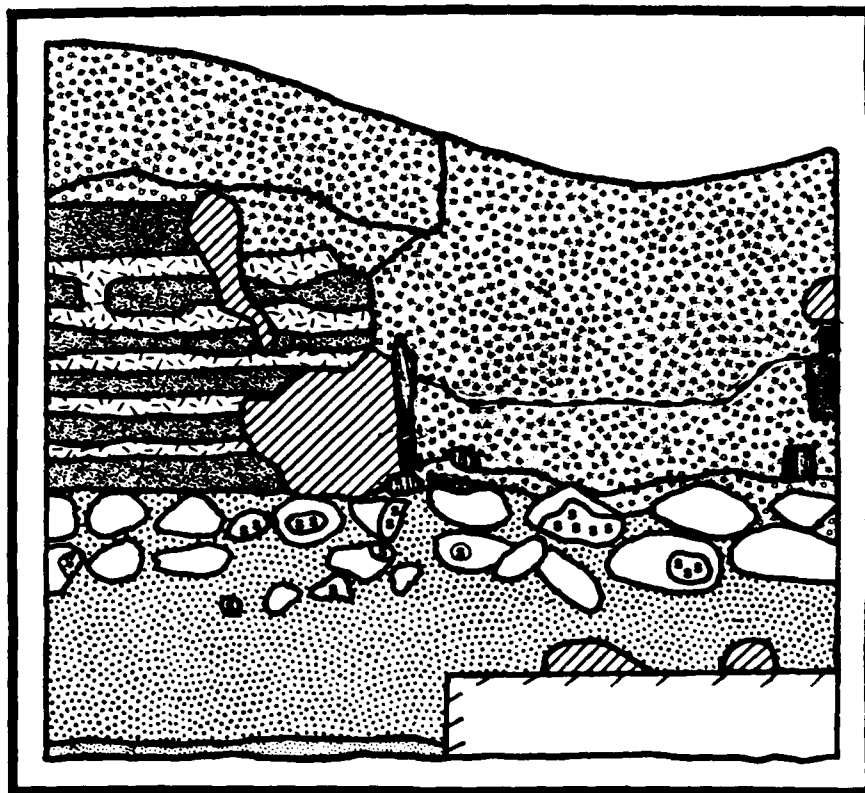
**Figure 7**  
**PROFILE OF UNIT B**  
**North Wall**

In Unit B, however, only two courses were observed. Cobbles in the lower course ranged from 0.15 to 0.30 m in length, and 0.10 to 0.20 m in height. There was no demonstrable gap between the courses, with the stones in contact. Stones in the upper course had the same range of size, and were relatively level.

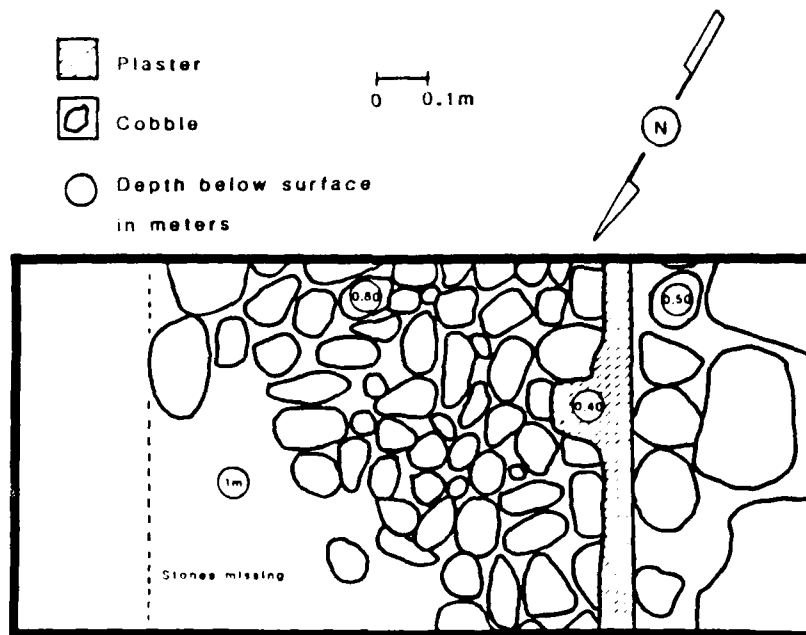
PLAN OF WEST WING WALL FOUNDATION

The width of the foundations could be evaluated only in Shovel Test 1, where it was 1.05 m (3.4 ft) wide exclusive of wall plaster (Figure 8). Although not fully exposed vertically, the upper course was composed of small cobbles similar to those observed in Unit D. A second course was approximately 0.05 m below the top cobbles, but it remains unknown at this time if there was a third course below. Above the top course of stone in all the foundations examined is a fine-textured mortar which acts as a base and level platform on which to lay the adobe bricks. There was no evidence of any mud mortar used between the stones of the foundations.

Another difference between the HABS plan and results of the field work occurred in Shovel Test 1. The HABS drawing indicated that the west wing wall was 2' 5" (0.74 m) thick at this point, whereas the wall was found to be 1.05 m where exposed in the area tested.

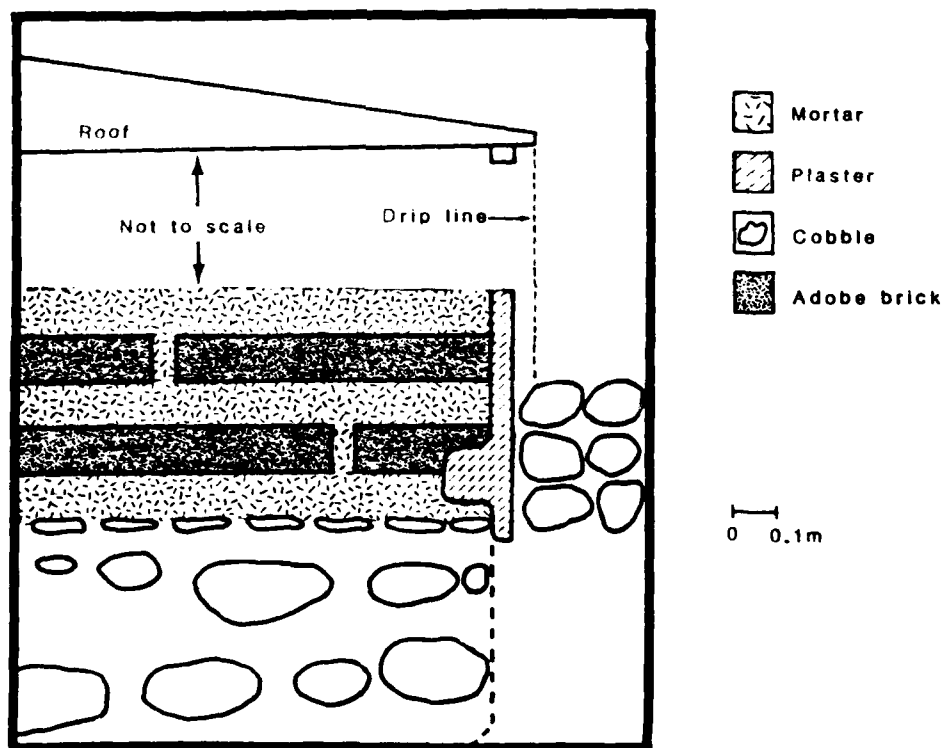
SCHEMATIC OF DRIP LINE AND FOUNDATION

of 0.25 m. The base of the lower course was approximately equal to the top of the foundation, presumably at the original grade, while the top of the upper course was 0.25 m above the top of the foundation (Figure 9).

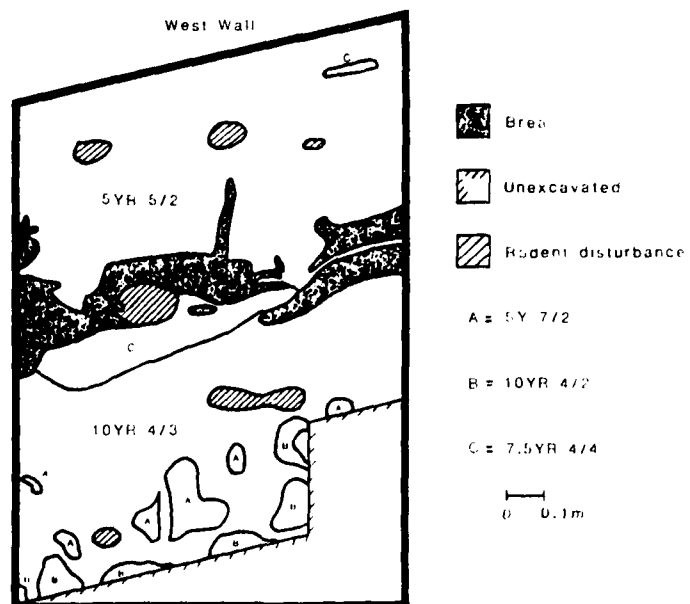
PROFILE OF UNIT C

West Wall

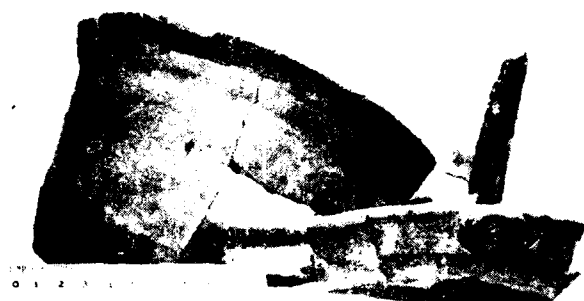
b. Cazuela (2)

This ware is the loza corriente of contemporary usage, the characteristic household pottery of Mexico. Such wares were widely traded from the seventeenth century onward, although after the annexation of California and the availability of other cooking pots, the trade seems to have declined. The single specimen seems typical of those known from west Mexico. Figure 13b.

Six sherds, 2, represent a cazuela, a wheel made, cylindrical cooking pot. There is the stub of a loop handle that rose from the lip; there was probably another similar handle on the opposite side, but that part of the rim is missing. If whole, the vessel would be about 16.5 cm (5.5 in) in diameter and 11.7 cm (4.6 in) high. The body is red (2.5YR4.5/8), with a thin wash of dark red slip (2.5YR3.5/6) covering the exterior from lip to the base. A very crudely applied red glaze (2.5YR4/6) begins 1.0 cm below the lip and covers the interior. The piece shows a great deal of wear, with the glaze worn off in the bottom of the interior and on the sides. The only west Mexican ceramic recovered during the test, it was found in Feature 1.

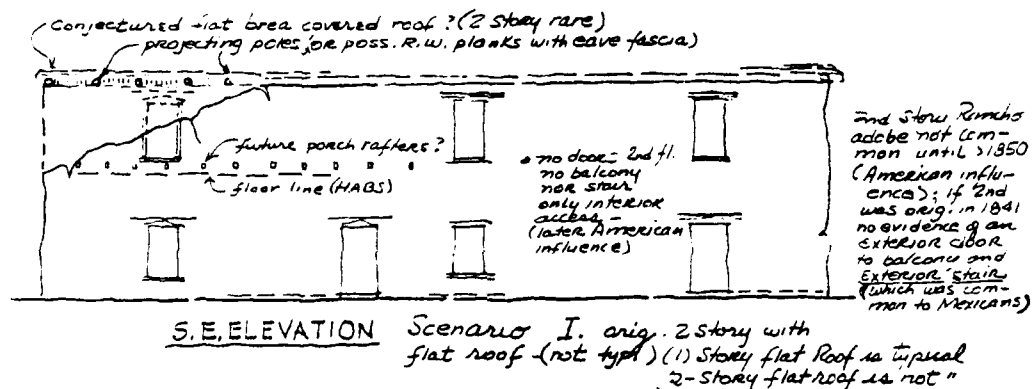
Previous reports have accepted that the Bandini-Cota Adobe was built as a brea roofed, two story dwelling, which would have appeared as suggested below.

The depiction implies certain assumptions: that the upper floor was reached by an interior stairway, rather than the exterior stairway with an upper balcony and door, and that brea was applied over poles parallel to the short axis of the structure, or possibly redwood planks, as at the William Workman Adobe of 1844. Other than legend, the best evidence for this proposition is contained in two Gould photographs ca. 1932-1935; at the west end of the south facade, there is a suggestion of remains of a lug sill and a filled-in window in the second story which would be directly above the westernmost window of the first floor. As indicated in the sketch above, the later roof line cuts

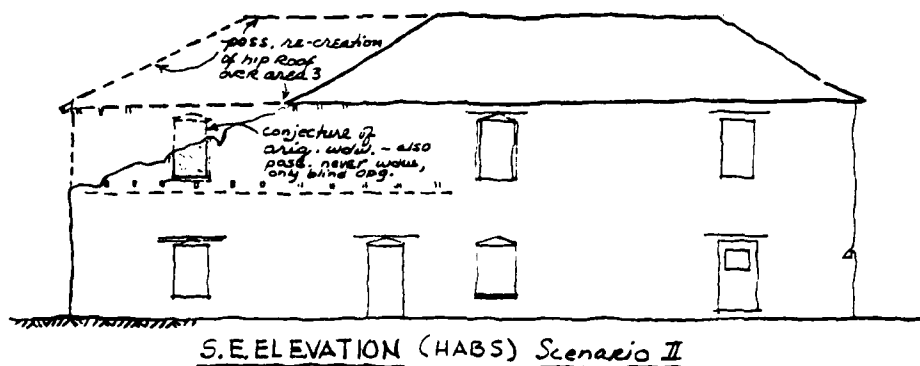
It is possible that after the brea was removed, the next stage in the evolution was a full hip roof which covered the entire perimeter of the walls.

This alternative would also provide an explanation for the enigmatic upstairs western window. In this version, as in Scenario I, there would have been full headroom in the second story at one time. The prototype for the silhouette, the Thomas Larkin house in Monterey, already existed by 1840, although the Bandini-Cota Adobe apparently never had a second story balcony.

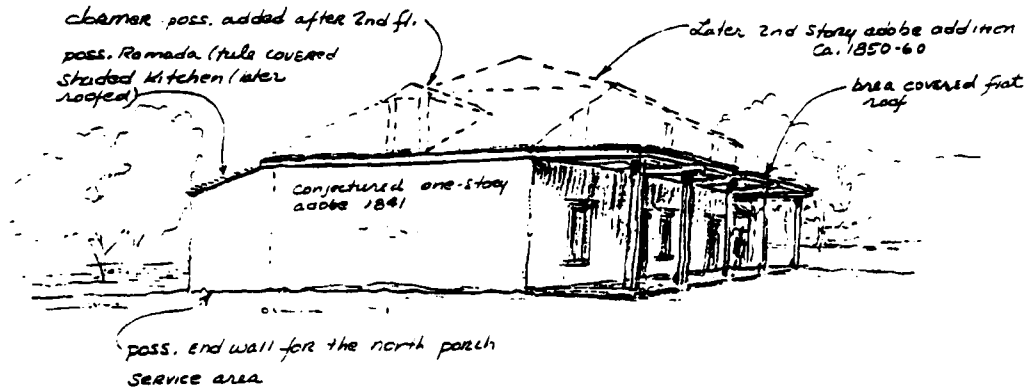
Finally, Scenario IV offers an informed conjecture of what the adobe might have looked like if it was first constructed as a one story building in 1840.

*Conjectured view from West ca. 1841  
(see also Pueblo photos and sketches and  
Rancho San Pedro (Dominguez) as late as ca. 1883*

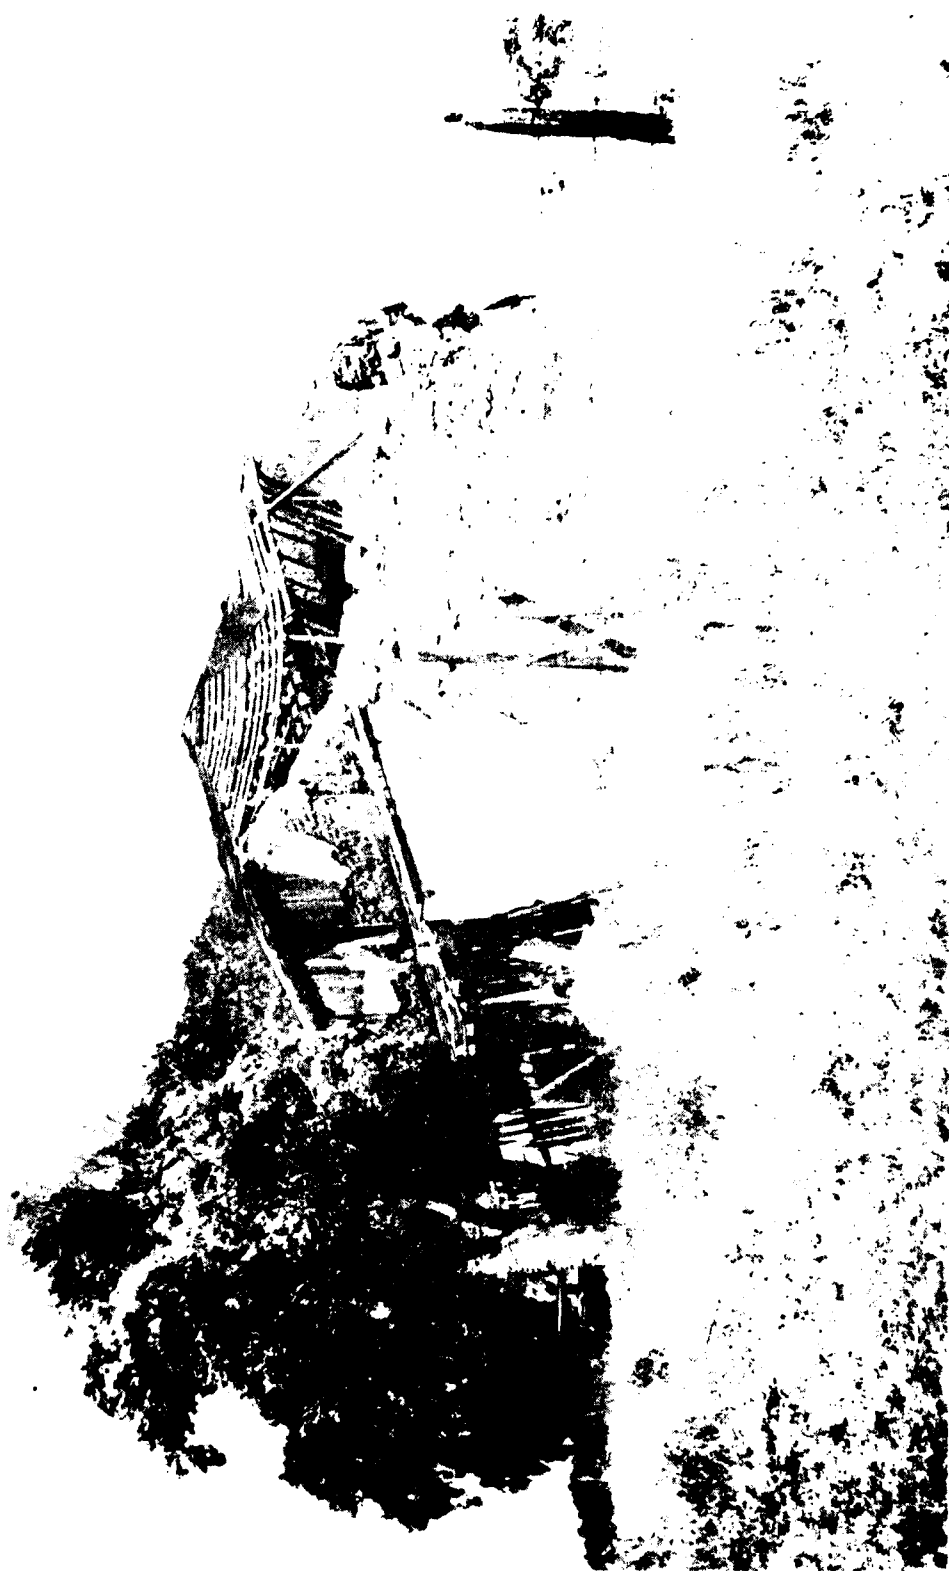
Figure 17

North and West Elevation  
CHAB-1936; Library of Congress

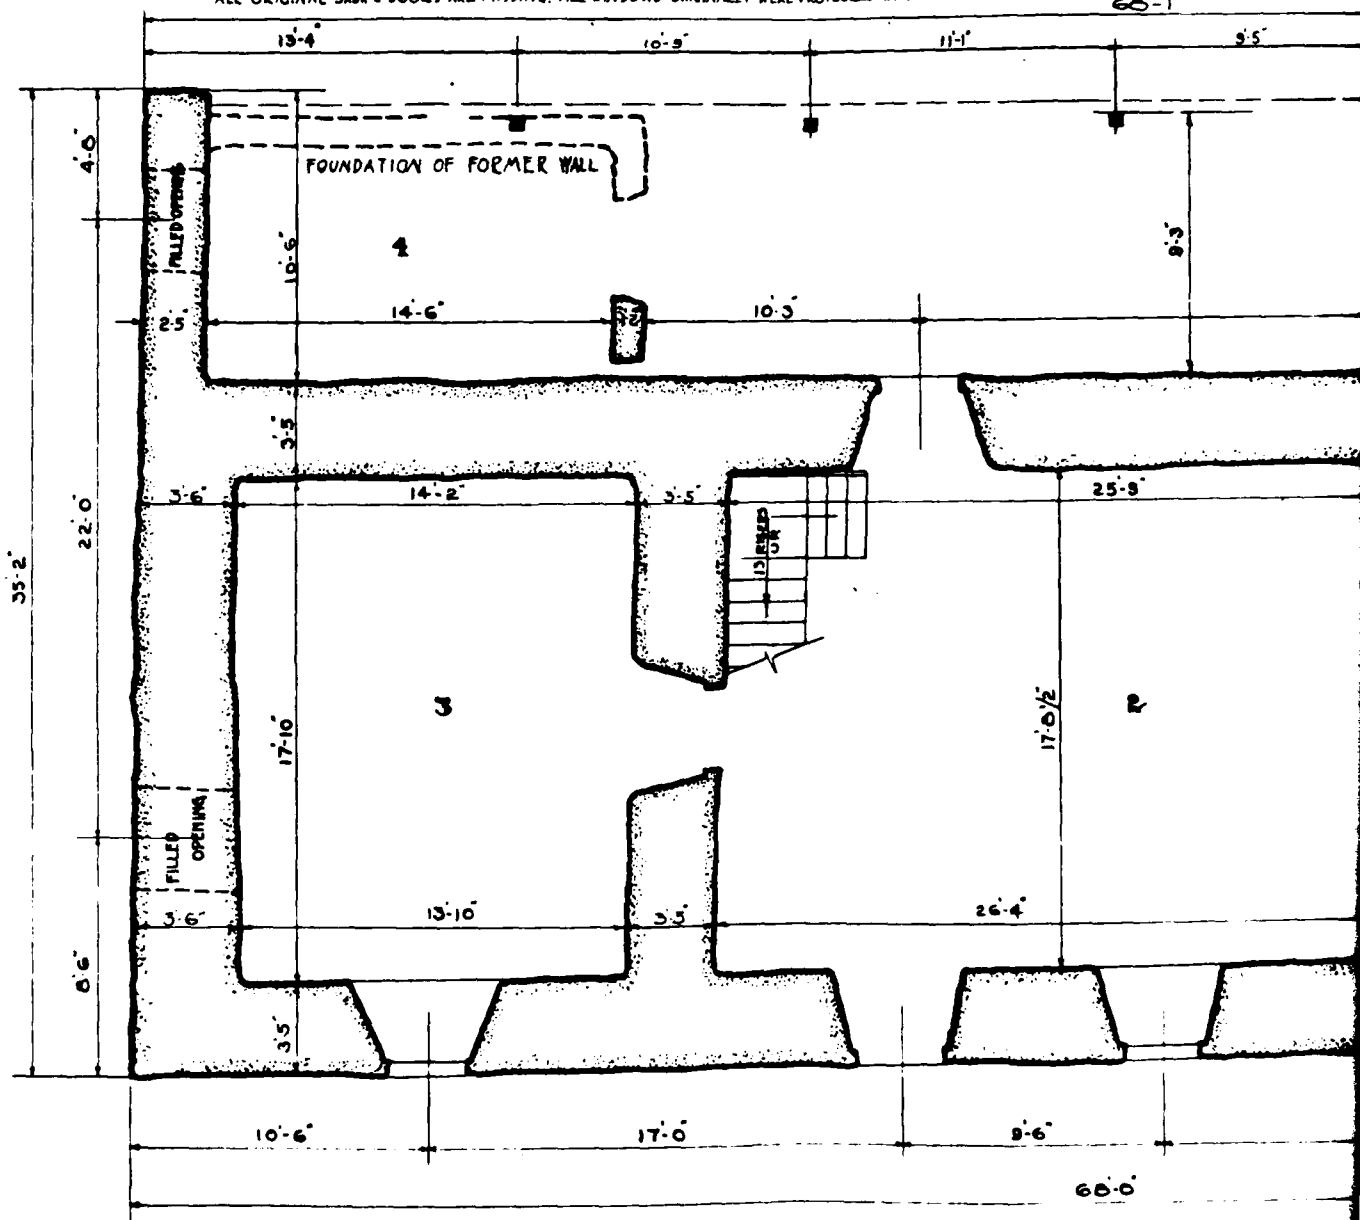
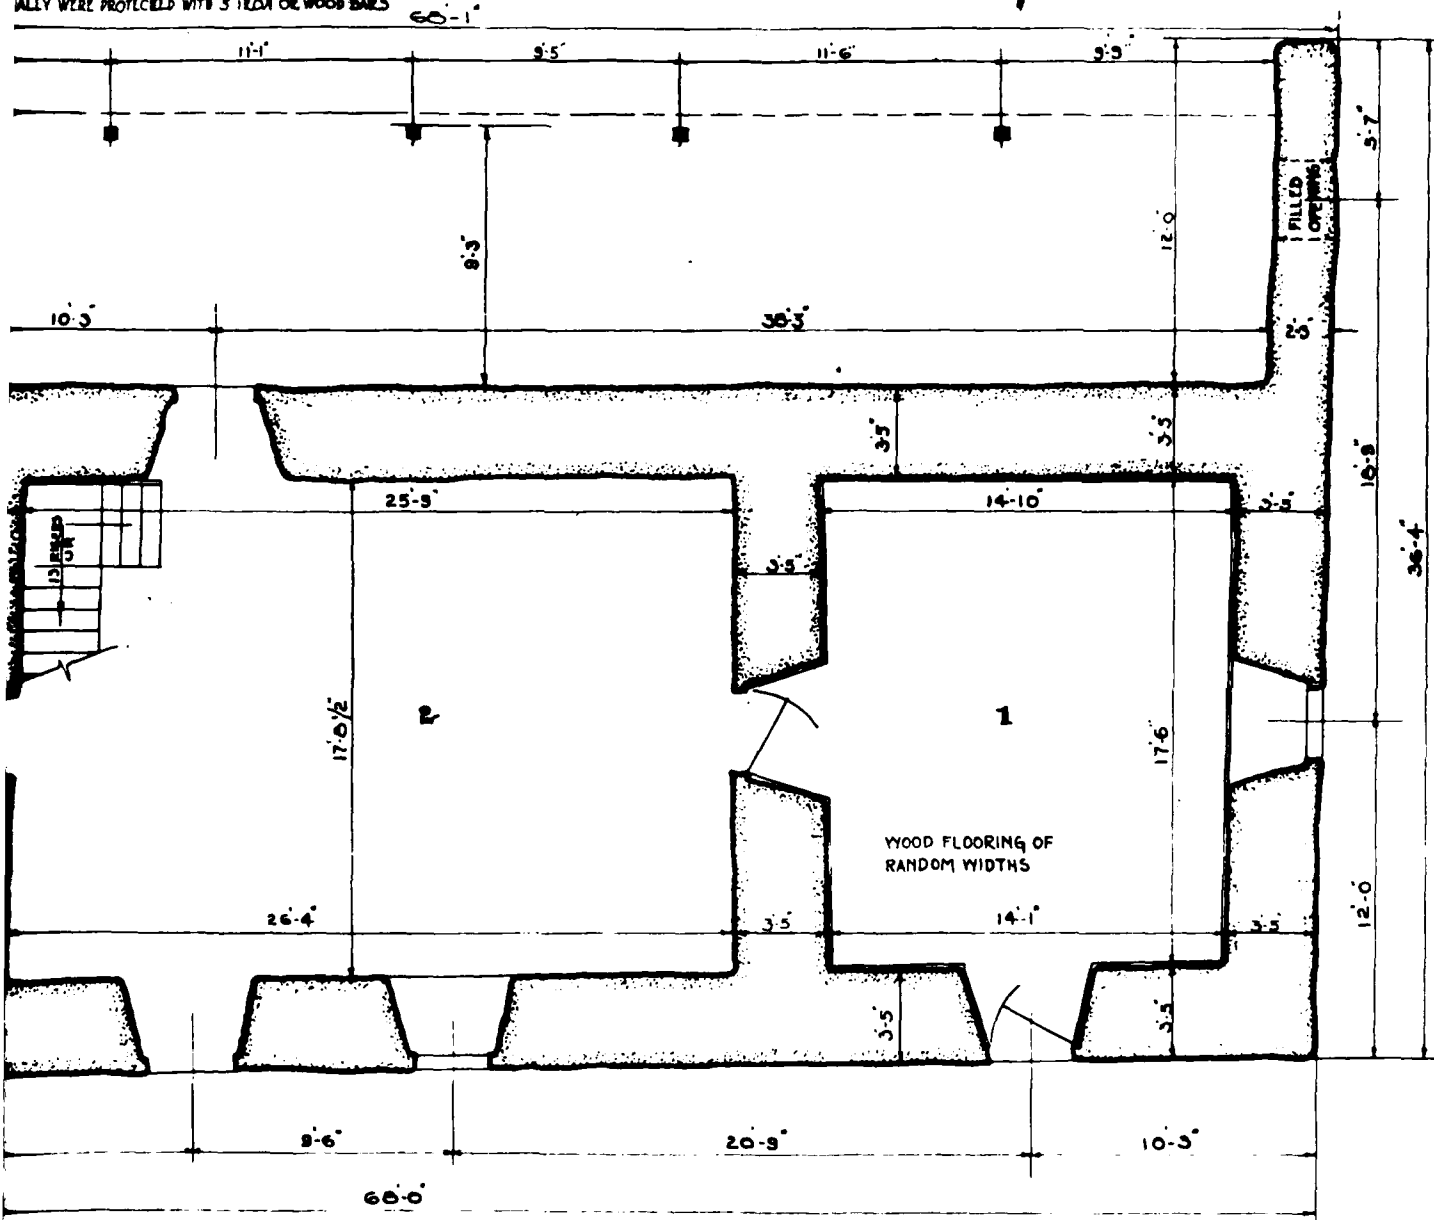
# FLOOR PLAN

ALL WALLS ARE OF ADOBE BRICK 5'0" X 4'0" X 12" WITH 1 JOINTS.  
EXTERIOR & INTERIOR WALLS WERE PLASTERED WITH 1/4" OF LIME PLASTER, 25% REMAINS.  
THE FOOTINGS ARE OF FIELD STONES LAID IN ADOBE MORTAR  
BUILDING ORIGINALLY HAD A ONE STORY COVERED CORRIDOR WITH BRICK PAVED FLOOR FULL LENGTH  
SOUTH SIDE, FLOOR REMAINS BUT BURIED.  
ALL EXTERIOR WOOD WORK WHITE WASHED AND INTERIOR WOOD TRIM WAS PAINTED GREY.  
THE FLOOR WAS LAID OVER SLEEPERS IN FIRST STORY DIRECTLY OVER SOIL, FLOORING IN ROOM NO.1 STILL REMAINS.  
THERE WAS A BASE AND HANDSCOT RAIL IN ROOMS 1 & 2 OF FIRST STORY AND ROOM 2 SECOND STORY.  
ALL ORIGINAL SASH & DOORS ARE MISSING. ALL WINDOWS ORIGINALLY WERE PROTECTED WITH 5'10" OR WOOD BARS

MOOD TRIM WAS PAINTED GREY.  
LY OVER SOIL FLOORING IN ROOM NO 1 STILL REMAINS.  
1ST STORY AND ROOM 2 SECOND STORY.  
WALLY WERE PROTECTED WITH 3' X 4' OR WOOD BARS

of the rooms. The actual distance, as revealed by excavation, from the same point in the east room where the wall was exposed in Unit A to the outer west wall uncovered in Unit D was found to be 49' 8", or a difference of six inches.

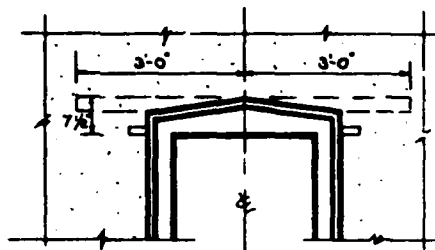
EXTERIOR ELEVATION  
ORIGINAL TRIM REMAINS ON ONE  
WINDOW ONLY
